Final Report

IMAGE SENSOR DATA BASE FOR THE DARPA ALV PROGRAM

C.D. MILLER
Sensor Systems Division
OCTOBER 1986

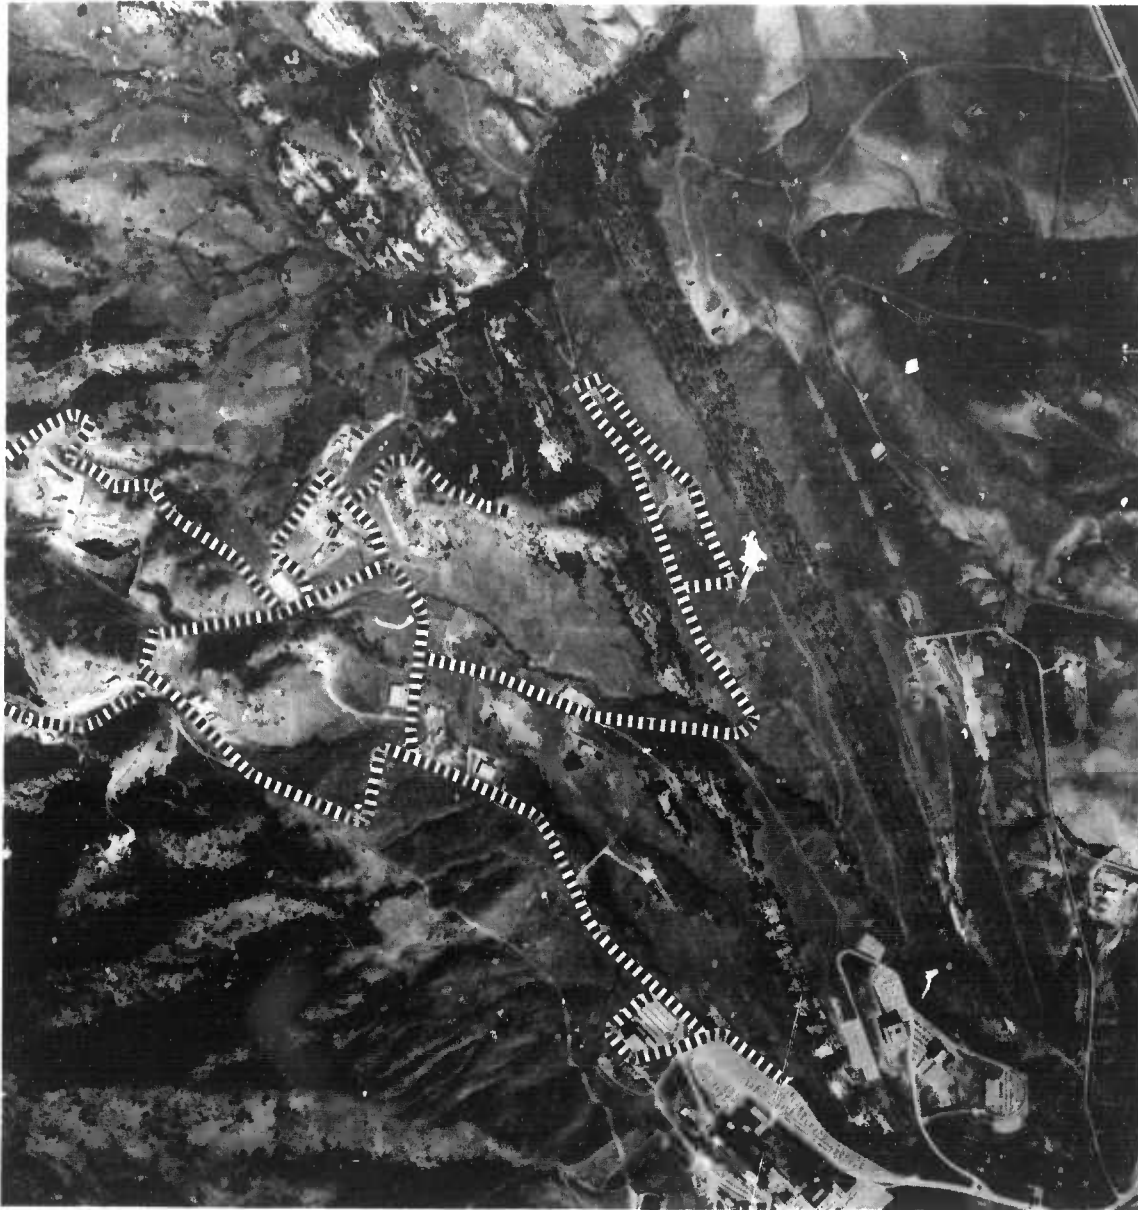
Figure 3-2. Measurement Test Sites - September 1984

----- Indicates Road Areas Traversed

selected for the scenarios; a few dirt roads were also traversed. See Figure 3-2. Data was gathered at speeds ranging from 5 to 10 miles per hour. Note, the DARPA/Martin test plan for the ALV called for demonstrations during 1985 of both 5 and 10 km/hr. The van was driven both on road centerline and the right hand lane in order to get representative data. Some data was acquired with the van weaving from side to side.

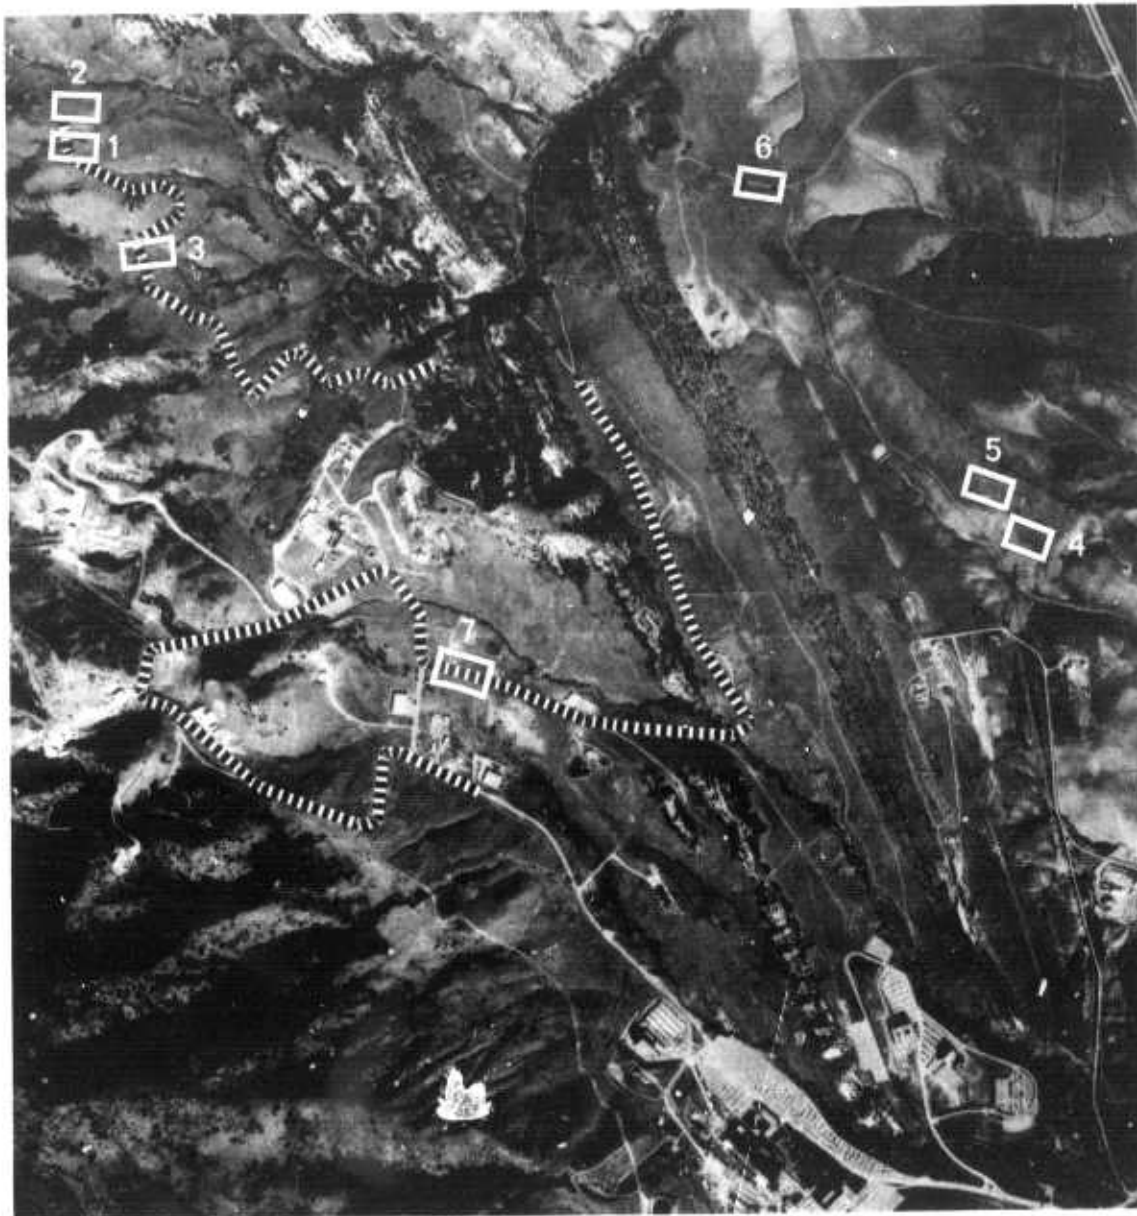
Figure 3-3. Measurement Test Sites - July 1985

----- Indicates Road Areas Traversed

□ Indicates MSS Sites

The MSS data cannot be acquired with the van moving since it takes approximately 10 seconds to acquire a frame of data and movement would cause unacceptable distortions in an image. Sites were selected such that the sun would be behind the van. Measurements were made usually in a sequence of 4 or 5 frames (positions) at each location. The initial frame would be taken and then the van with sensors moved ahead 30-50 feet and the process repeated. The 3D sensor and TV system were also operated simultaneously with the MSS. Seven locations were imaged in two days of operation, resulting in 42 runs of MSS data. It was not possible to operate during evening hours due to cloud build-up over the site. As can be seen from the data logs in Appendix B, morning data acquisition was performed from approximately 06:30 until 09:30. Figure 3-3 indicates the locations of the road networks and the selected MSS sites over which data was taken.

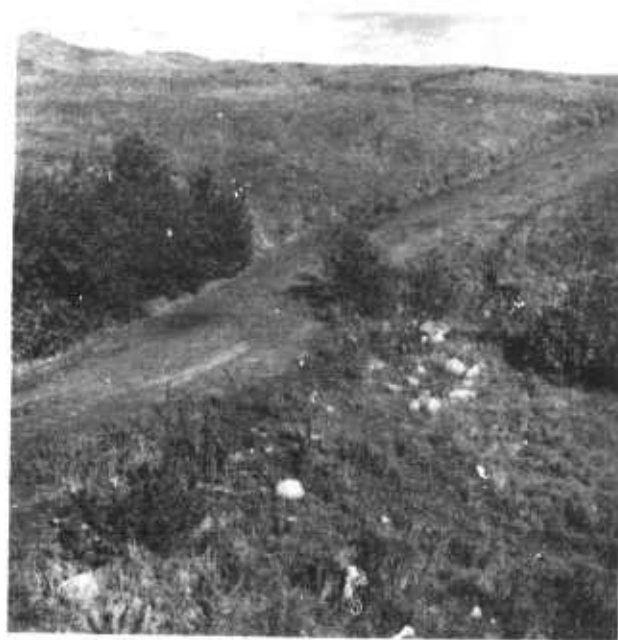
Figure 3-4. Photograph of Ground Scene Near ETL Site #89

A typical scene for MSS data is shown in Figures 3-4 and 3-5. This location was chosen near ETL Site #89 and was selected not only for solar aspect but for the diverse types of background components in the scene. Note the various vegetation types, dirt road with puddle of water, rocks, etc. The photographs were taken from the sensor platform. Note the shadow of the sensor and photographer in the foreground of Figure 3-5 which indicates the sun is directly behind the sensor thereby achieving a small bistatic angle between the sun, sensor, and target area.

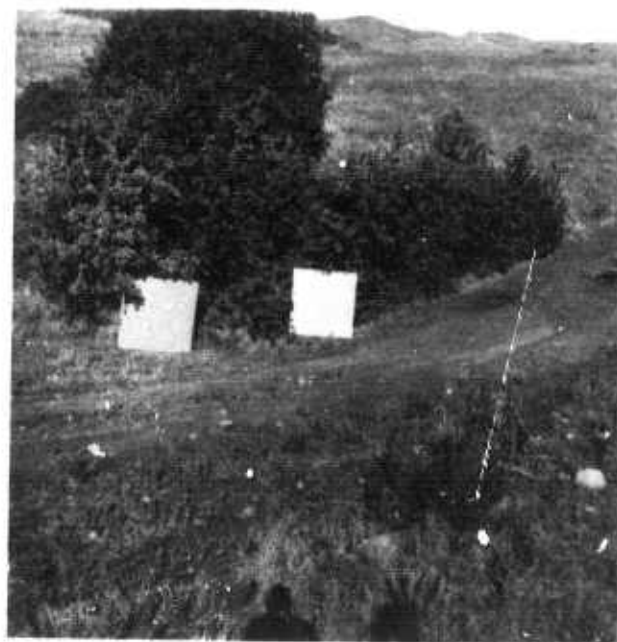
Figure 3-5. ETL Measurement Site #89 with Calibration Panels

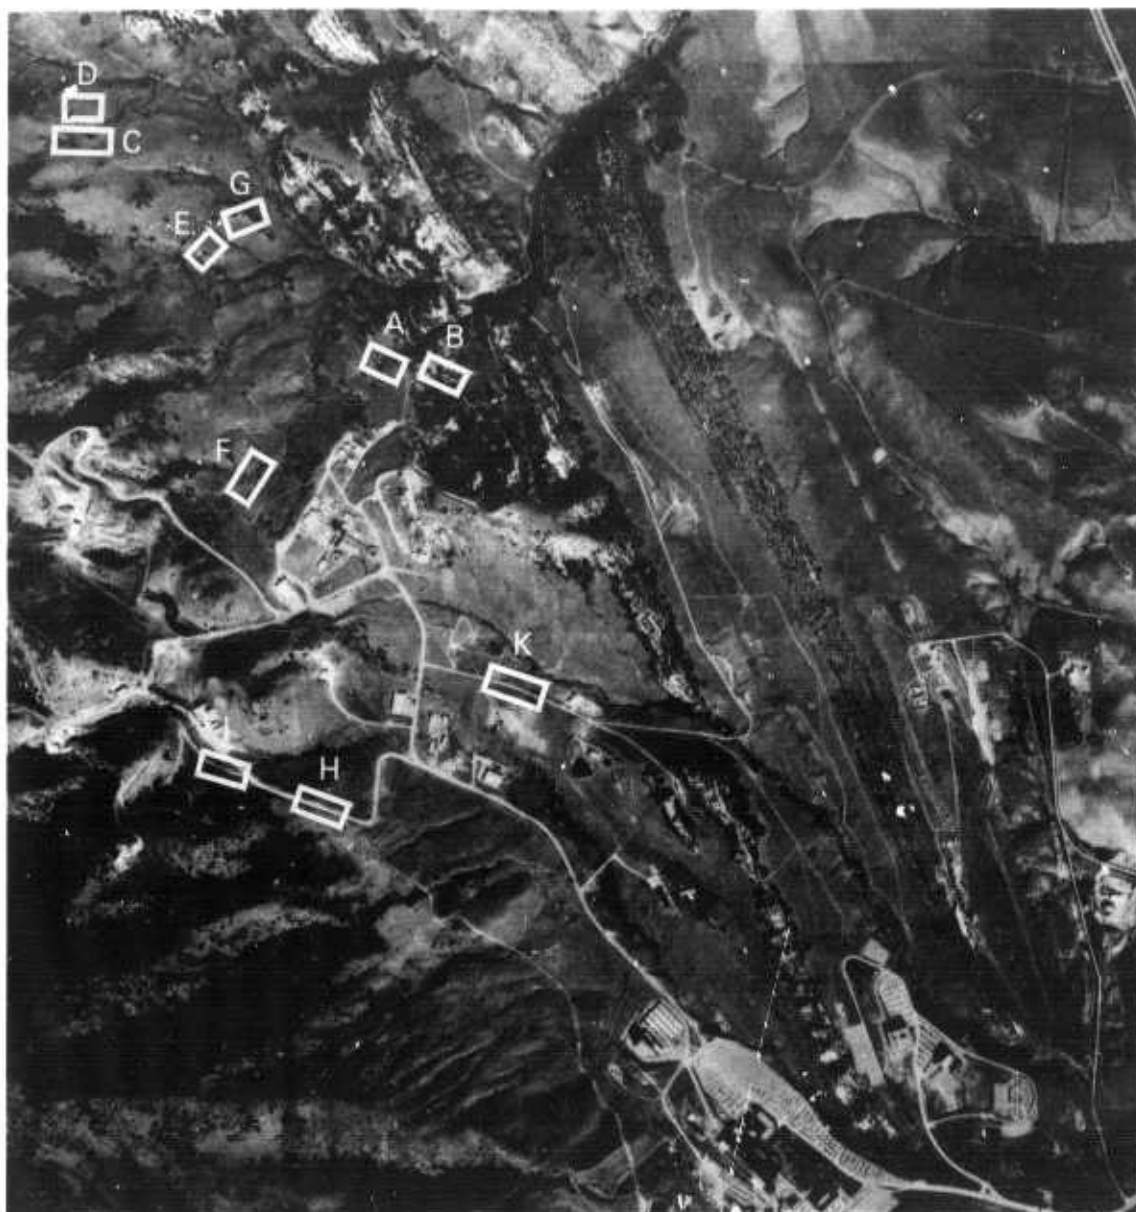
Figure 3-6. Measurement Test Sites - September 1985

□ Indicates MSS Sites

Measurements were made at a total of ten different sites with a total of 42 data runs. See the data log in Appendix C. Figure 3-6 shows the Denver site overlay with the measurement sites indicated.

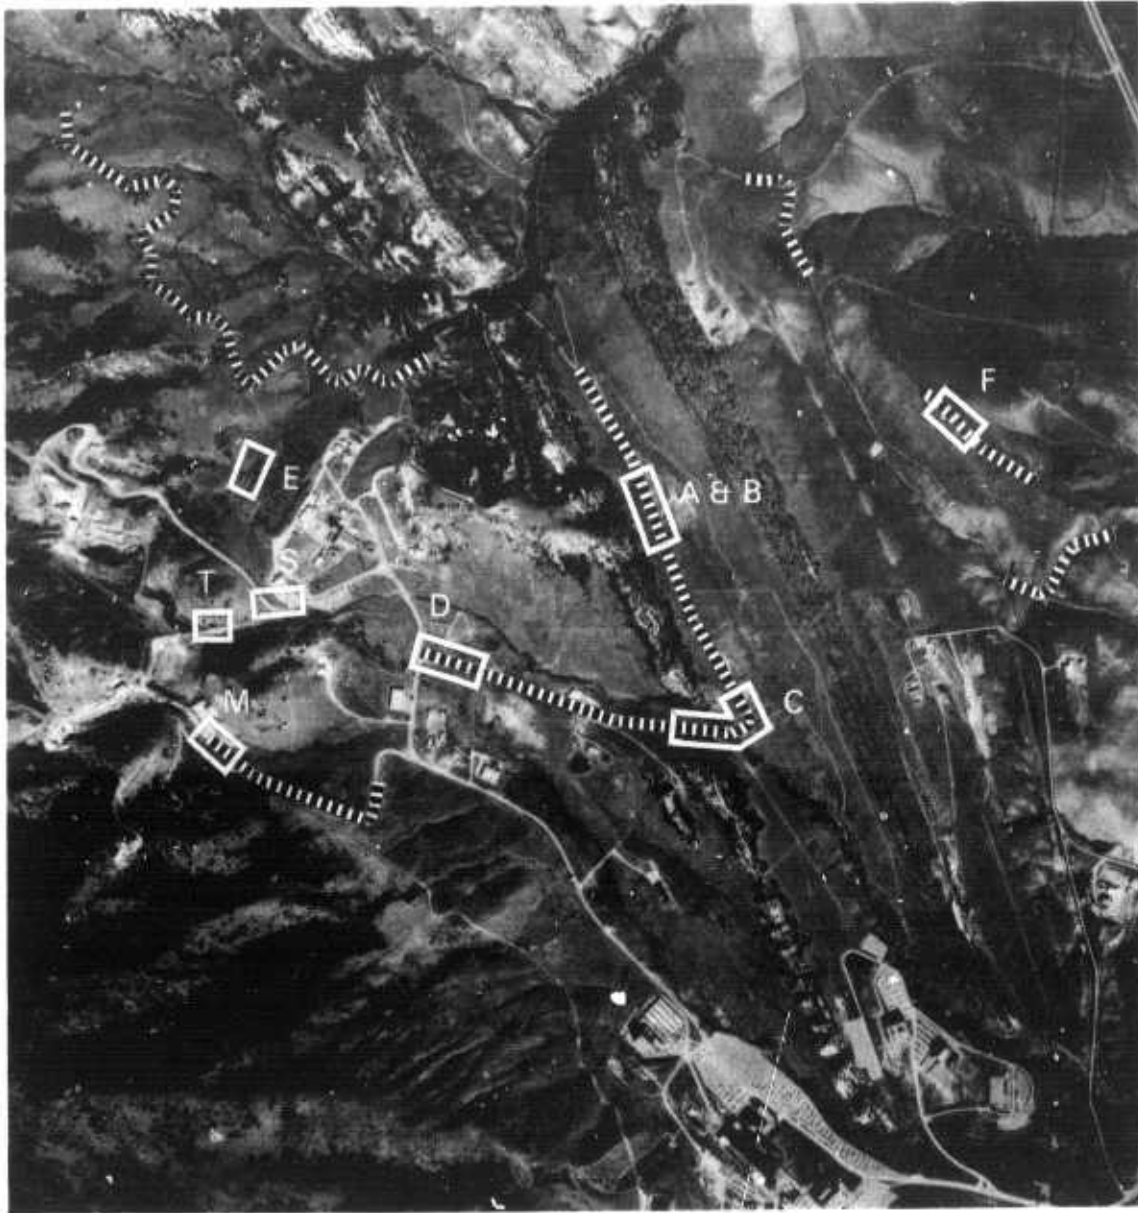
Figure 3-7. Measurement Test Sites—May 1986

----- Indicates Road Areas Traversed

□ Indicates Scenario and MSS Sites

The emphasis during the May measurements was on specific calibration sequences laid out by Martin. Eight scenarios were programmed to provide animated collection of data simulating speeds over various roads, terrain, etc. See Table 3-1 for a listing of the scenarios. Site locations are indicated in Figure 3-7.

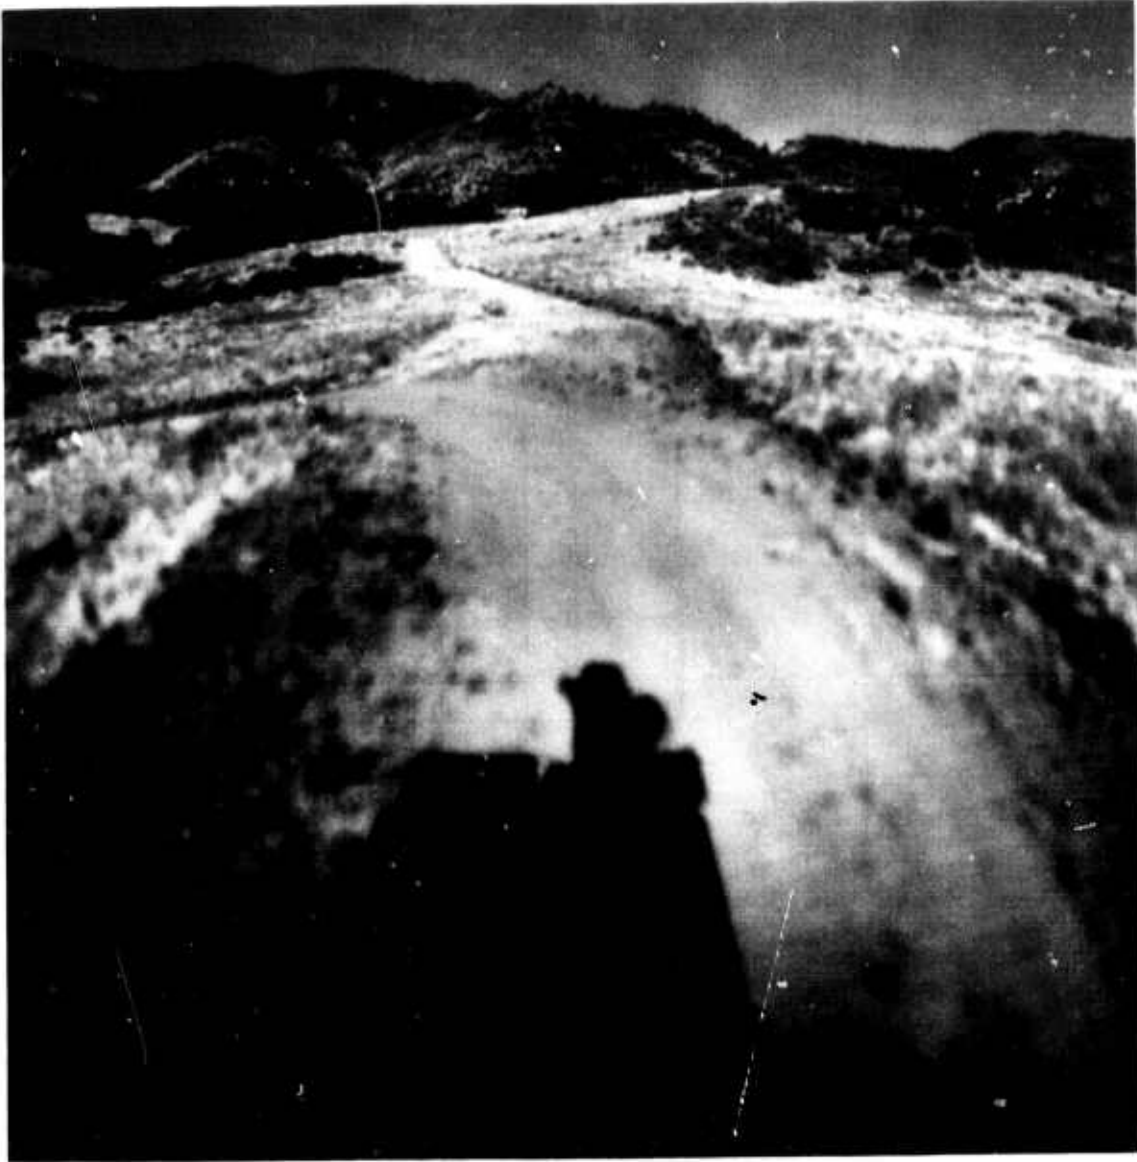
Figure 4-2. Multi Spectral Image, July 1985, Run 12, Band 2
